**The MENA Region Initiative as a Model of
NEXUS Approach and Renewable Energy Technologies (MINARET)**

**Off-Grid Photovoltaic System for the Sport Facility
in Jdeideh Al Chouf (Tender No: 12/2021)**

Preliminary Handover Report

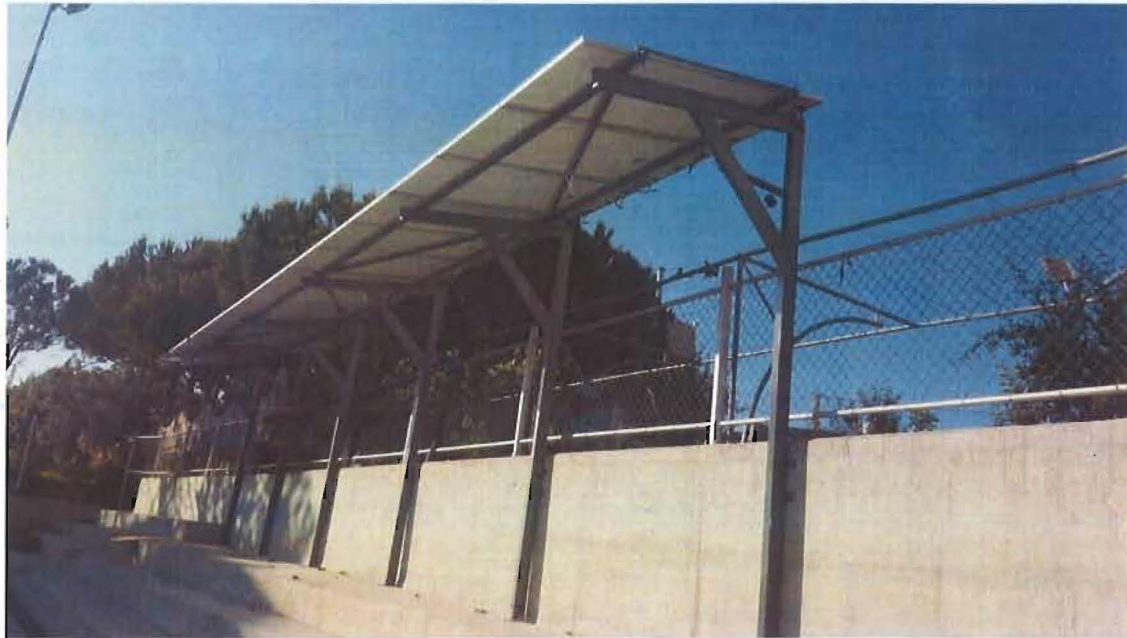
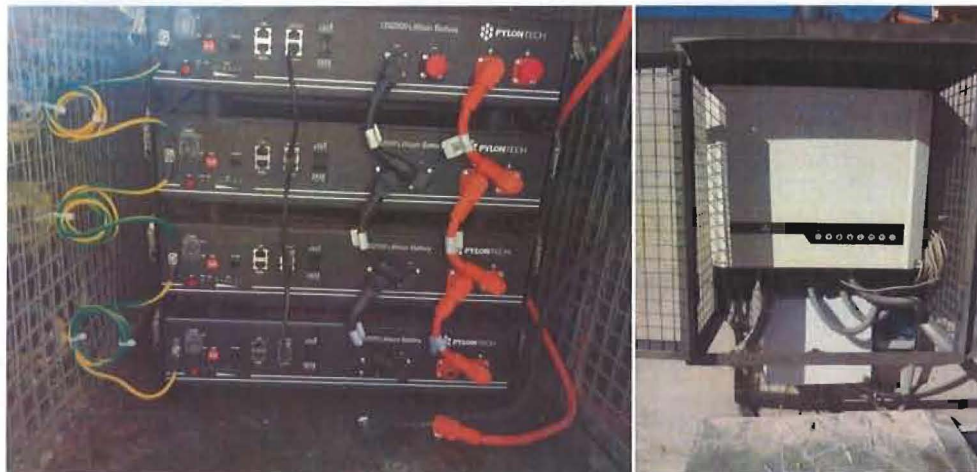
Figure 1: Installed PV Modules, PylonTech Batteries and GoodWe Inverter

- PV Modules: ZNShine Polycrystalline 72 cells, 335 Wp. The PV Modules are connected in two arrays on 15 modules.
- Batteries: Pylontech Lithium Iron Phosphate 48V, 2400 Wh connected in parallel
- Mounting Structure: as per the proposed drawings
- Inverter: GoodWe single phase 5.0 kW with two MPPT trackers
- DC fuses, DC breakers, AC breaker as per the inverter SLD
- Communication cable between the batteries & inverter and the inverter & meter.
- Earthing system

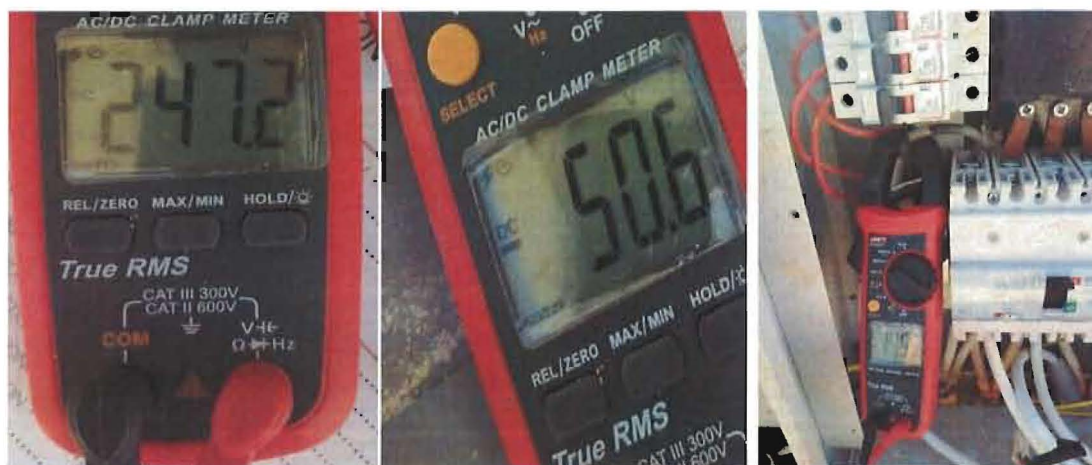
Measurements	5 kWp Off-Grid PV system with storage 10kWh
PV Array measurements (V)	247.2 V
Battery Voltage (V)	50.6 V
AC current when all lights in the sport facility are ON	19.55 Amp

Figure 2: Measurements on PV System

The PV systems consist of two arrays. One of the arrays has 8 PV modules and the other has 7 PV modules in series providing a total of 5 kWp. The GoodWe inverter is connected through 2 DC inputs with MPPT operating voltage range 120 V ~ 500 V. The system is currently not connected to the utility grid because there's no utility subscription for the sport facility, but the breaker is ready to be connected once the utility is there.

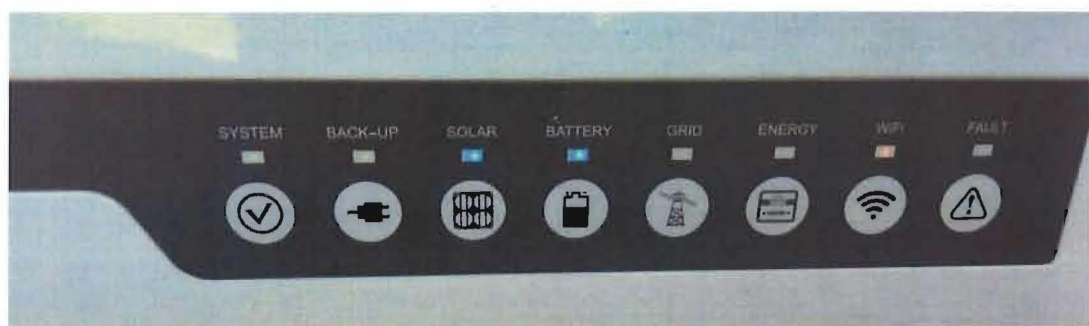
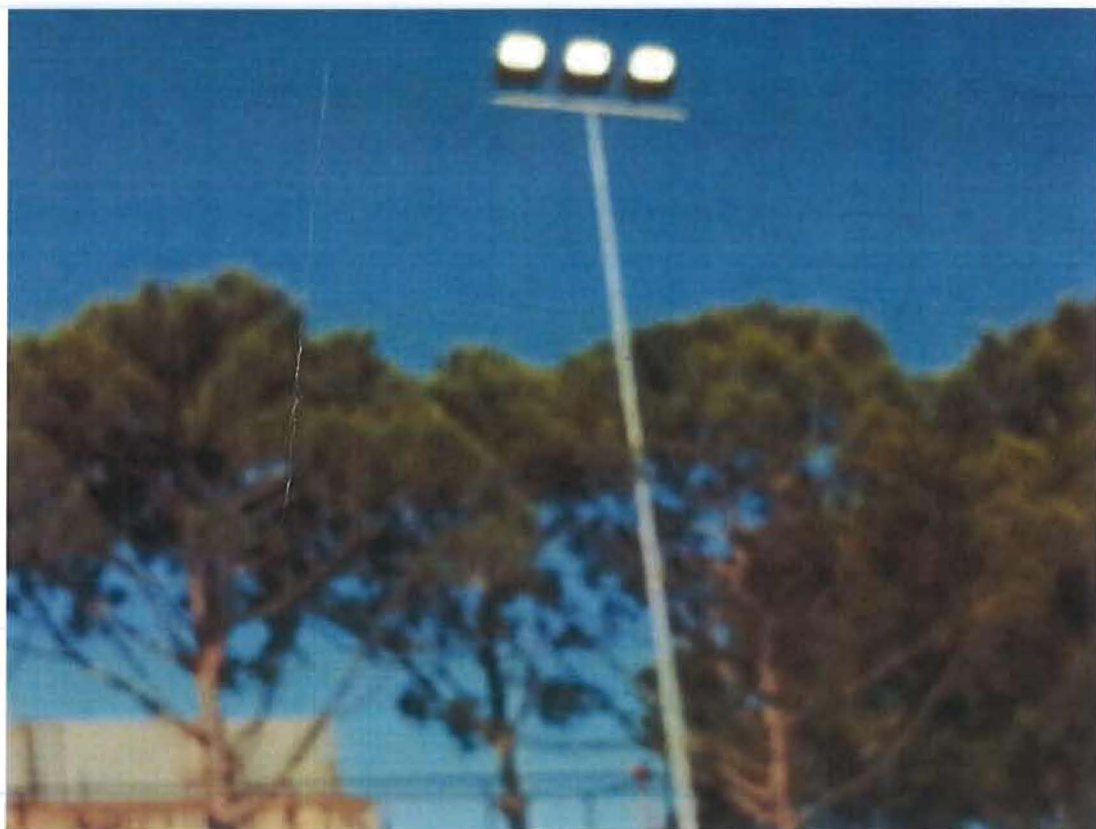
Figure 3: Running System

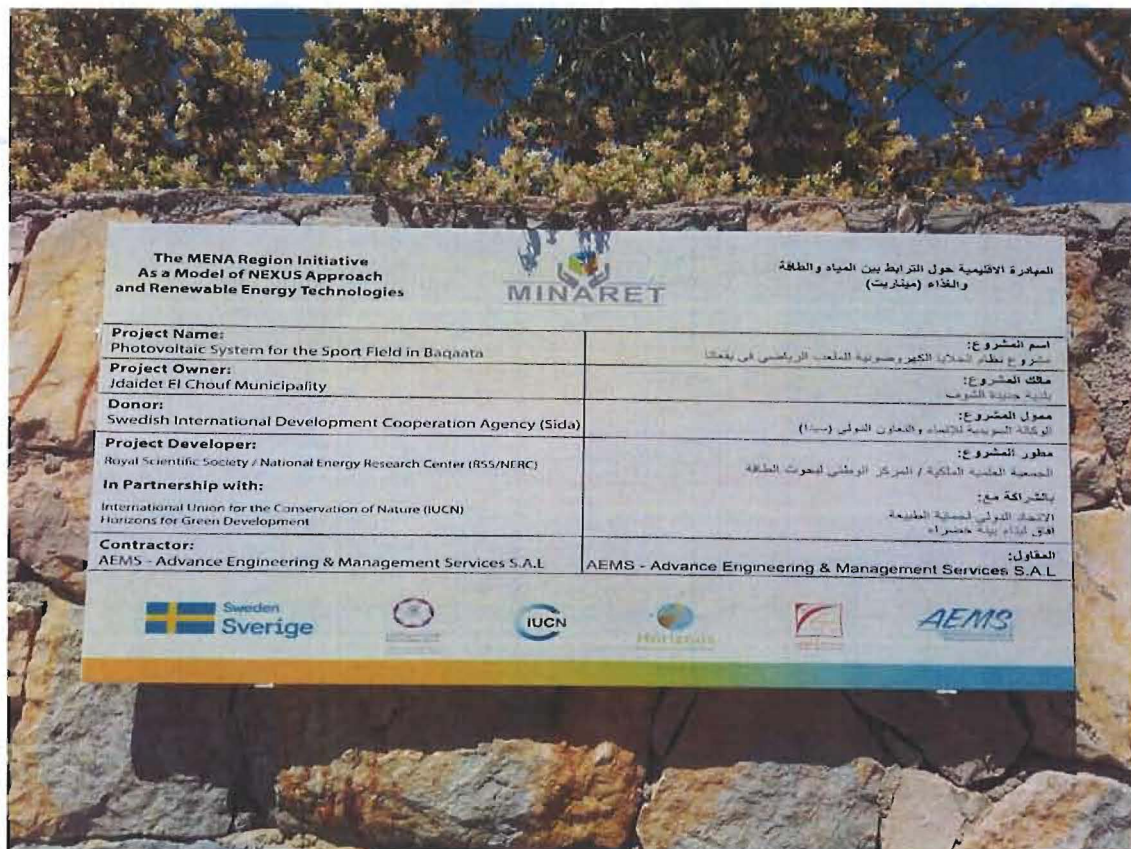
The signage in metal frame structure with digital printing on outdoor vinyl with 150cm height * 70cm width fixed on galvanized steel was installed on the wall of the Sport facility as agreed with the municipality.

Figure 4: Project Signage

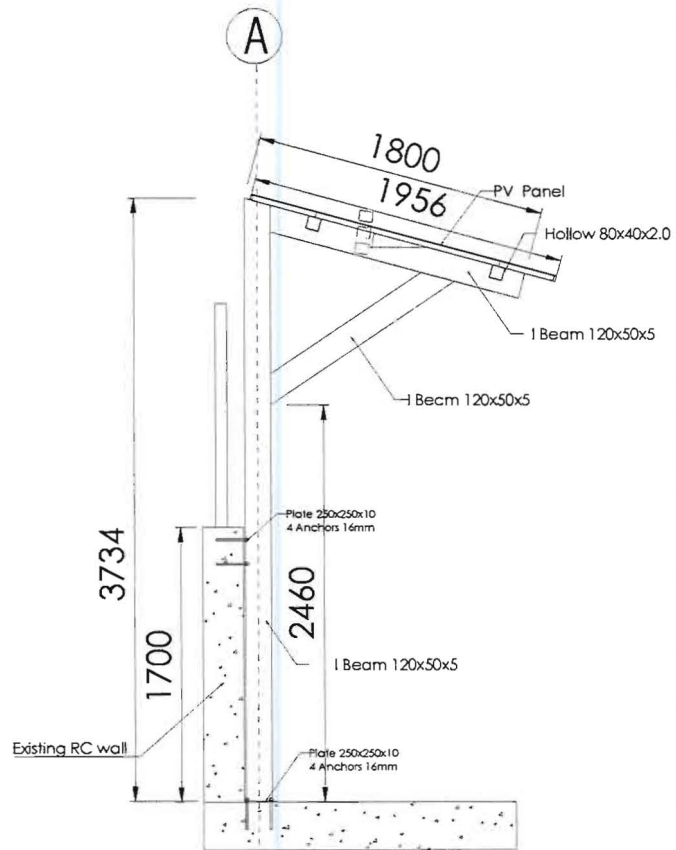
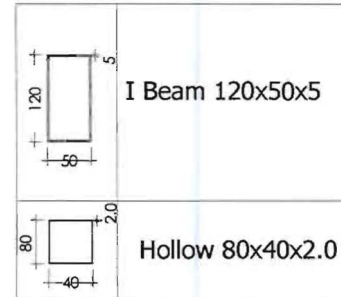
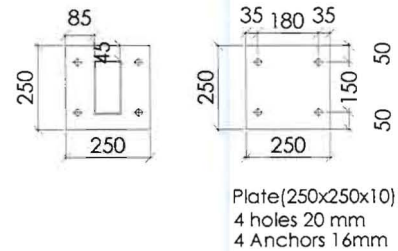
S.01

Frame Section

Item	Profile	Unit	Qty	Unit weight (KG/Unit)	Total weight (KG)
1	I Beam 120x50x5	M	42	10.6	445.20
2	Hollow 80x40x2.0	M	36	4.25	153.00
3	Plate 250x250x10	PCS	6	4.9	29.40
				Sum	627.60

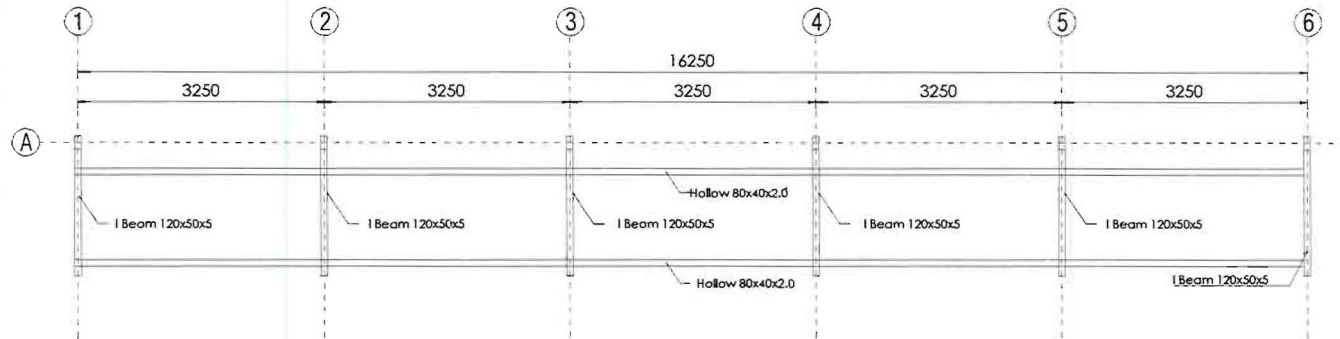
Structural layout

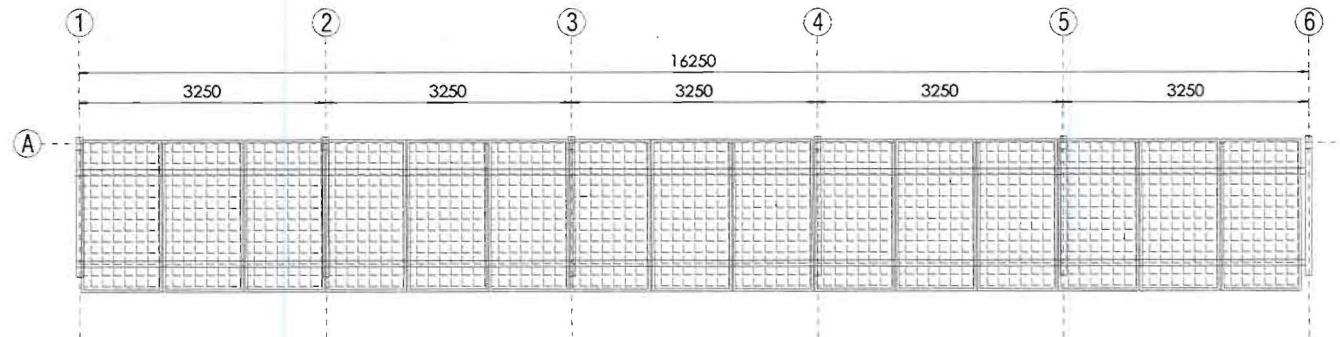
POLYCRYSTALLINE SOLAR
MODULE Layout QTY = 16
